Chapter 3

Why Adopt a Seismic Code?

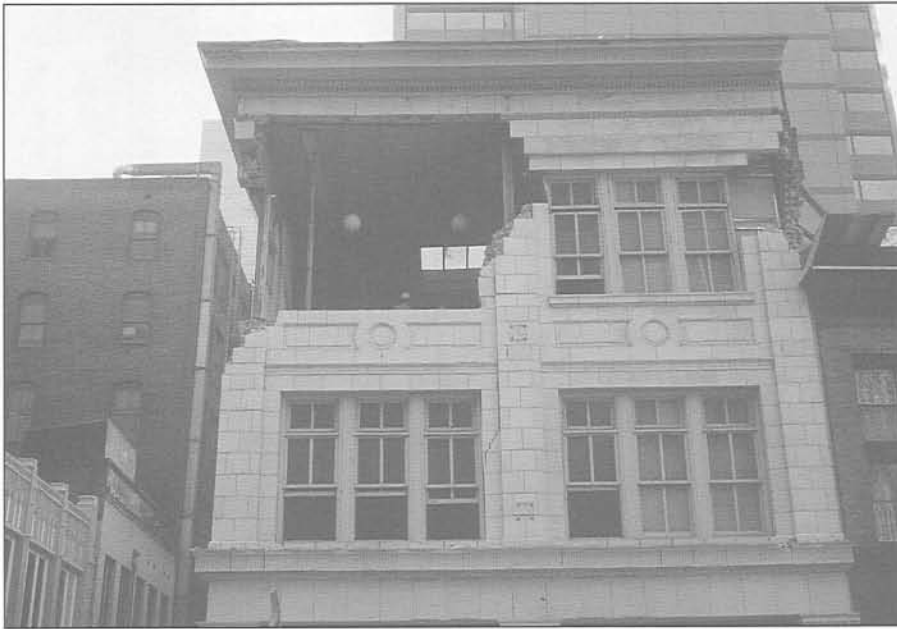
FIGURE 3.1 Most of the building damage in the 1989 Loma Prieta earthquake was to older unreinforced masonry buildings built before the adoption of seismic codes. (Photo: Rob Olshansky)

The Loma Prieta earthquake clearly illustrates the effectiveness of seismic codes. Occurring on October 17, 1989, this earthquake measured

7.1 on the Richter scale and was the strongest to affect a U.S. city since the 1964 Alaskan earthquake.¹ It shook the San Francisco Bay Area and killed sixty-three people. Two-thirds of the deaths were a result of the Cypress viaduct collapse. Although the ground-shaking was intense within the metropolitan area, few buildings collapsed. Most of the damage occurred to unreinforced masonry buildings built before the adoption of seismic codes. Nearly all major reinforced concrete structures built after World War II survived without collapse. Even at the quake's epicenter new buildings and buildings located on firm ground suffered little damage. Informed observers attribute the success to the required UBC seismic codes.² This example illustrates that code requirements reduced the damage and loss of life during this moderate earthquake.

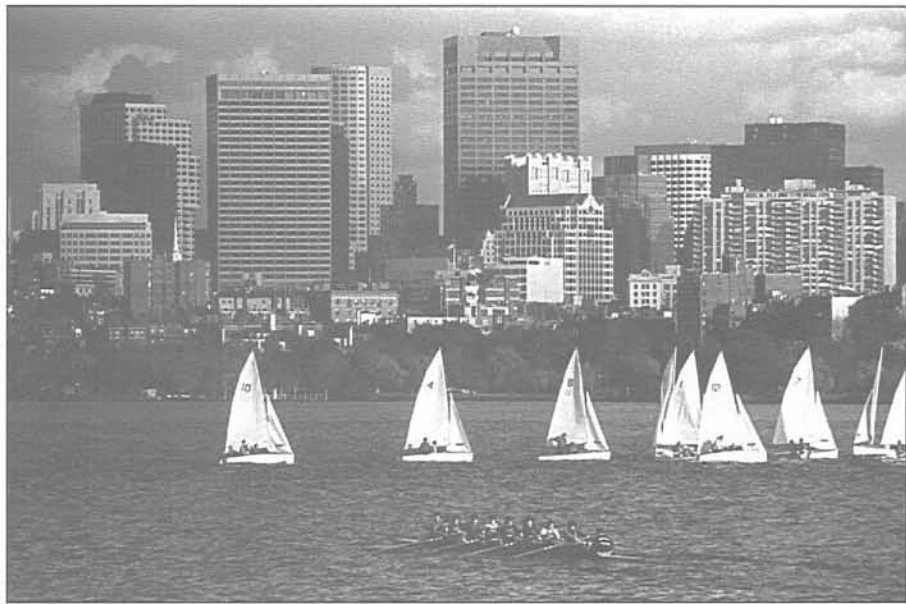
FIGURE 3.2 Lessons about underlying soil conditions learned in the 1985 Mexico City quake can help areas built on fill, such as the Back Bay area of Boston shown above, minimize damage. (Photo: Greater Boston Convention & Visitors Bureau)

New lessons are learned from every earthquake and incorporated into U.S. seismic codes. For example, the 1985 Mexico City earthquake confirmed that the local soil condi-

tions are as important to building stability as the epicenter location.⁸ In response to this new information, ICBO in the 1988 and 1991 UBC editions has emphasized soil conditions by increasing the force requirements according to the type of underlying soil. *The National Earthquake Hazard Reduction Program (NEHRP) Recommended Provisions* (described on page 8) have also taken into account soil conditions in the latest edition.

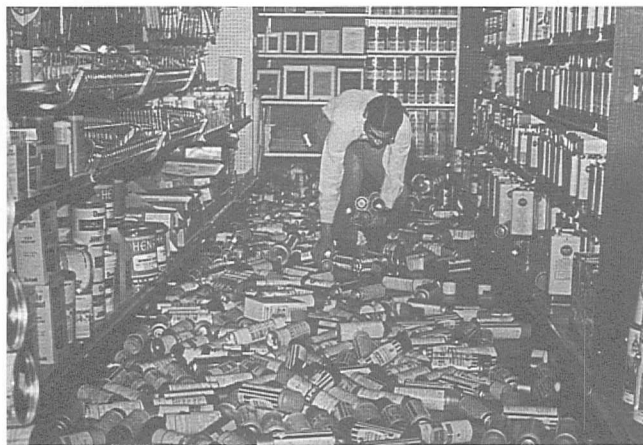
MMI VI: Ground-shaking felt by all; some cracked plaster; broken dishes and glassware. (Photo: Caltech EERL)

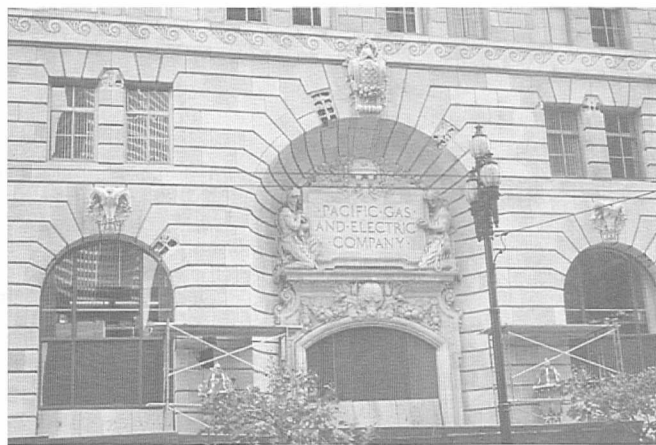
MMI VII: Disturbance frightens all; cracked chimneys; cracking in unreinforced masonry structures. (Photo: Rob Olshansky)

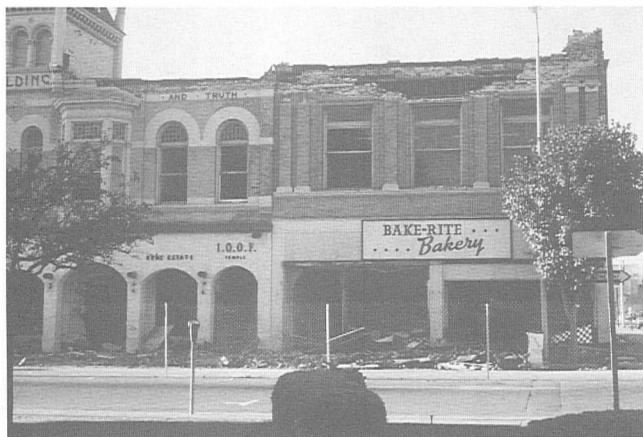
MMI VIII: Causes near panic; partial collapse of unreinforced masonry structures. (Photo: Rob Olshansky)

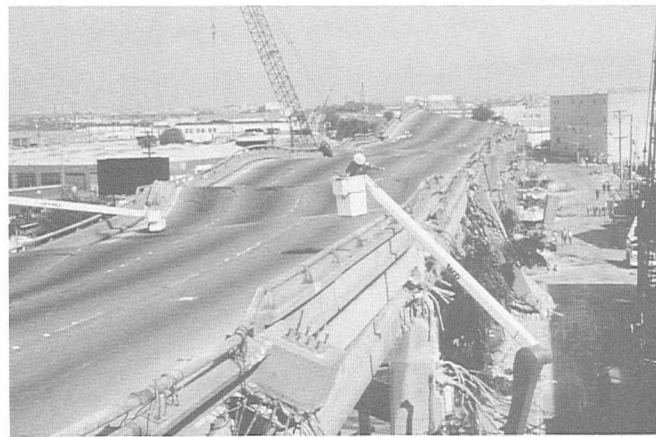
MMI IX: General panic; ground-cracking; considerable damage in buildings designed to seismic code. (Photo: J. David Rogers)
